# **Plutonium Intakes at the Savannah River Site FB-Line on September 1, 1999**

**Chuck Radford, DOE-SR  
Tony Weadock, EH-10**

**Subject: Pu-239 Release/Worker Intakes**

**Contractor: Westinghouse Savannah River Company**

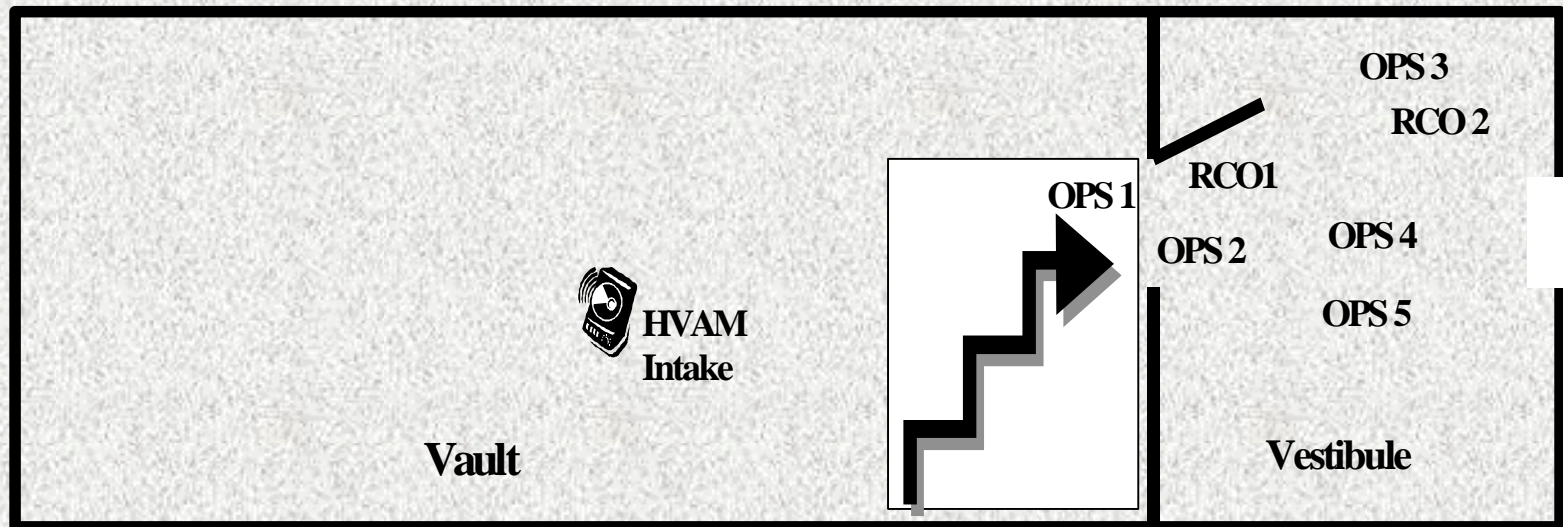
# Diagram of Vault/Vestibule Area

- ◆ **Defective weld on plutonium storage can led to FB Line Pu-239 release on 9/1/99. Seven workers were working in vault/vestibule preparing cans for transport.**
- ◆ **Eight workers (one cross-contamination) received intakes; one in excess of annual limits**
- ◆ **Type B Investigation conducted by DOE-SR; report issued 2/2000 ([http://tis.eh.doe.gov/oversight/acc\\_inv/acc\\_investigations2.html](http://tis.eh.doe.gov/oversight/acc_inv/acc_investigations2.html))**
- ◆ **EH-Enforcement investigation conducted 4/2000**
- ◆ **EA -2000-08 issued 7/2000; PNOV and 220K civil penalty**

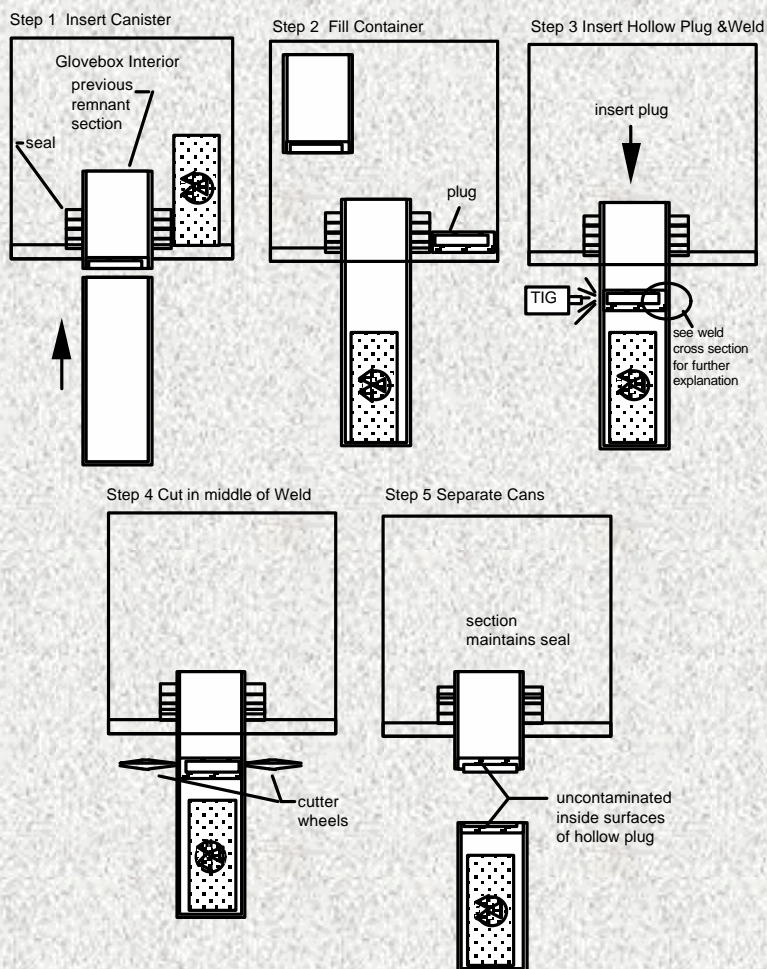
## BAGLESS TRANSFER PROCESS

- ◆ Insert new canister into glovebox, displacing previous canister from sphincter seal.
- ◆ Place plutonium into canister & backfill with Helium.
- ◆ Insert plug into canister and weld plug to canister, applying three tack welds and overpass weld.
- ◆ Cut container in center of the weld.
- ◆ Leave upper portion of canister in sphincter seal to maintain glovebox integrity & remove welded canister containing plutonium.
- ◆ Weld visually inspected by Operator.
- ◆ Volumetric and Helium leak check performed by Operator.
